# Improvement Of Abnormal Wear Between The Vane-slot And Vane In Rotary Compressor

**Bo HUANG\*, Guo qiang GAO**

SHANGHAI HITACHI ELECTRICAL APPLIANCES CO., LTD.  
SHANGHAI 201206 CHINA

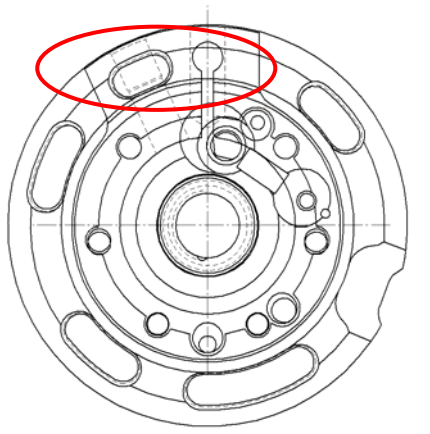
UE-BEAR①

The kidney shaped hole at the upper-bearing which we are using now is not in contact with the vane-slot (UE-BEAR①) and this would affect the lubrication of the vane-slot. Otherwise if the hole is in contact with the vane-slot(UE-BEAR②), It will increase the lubrication at the vane-slot. Later we will make efforts to improve the lubrication structure.

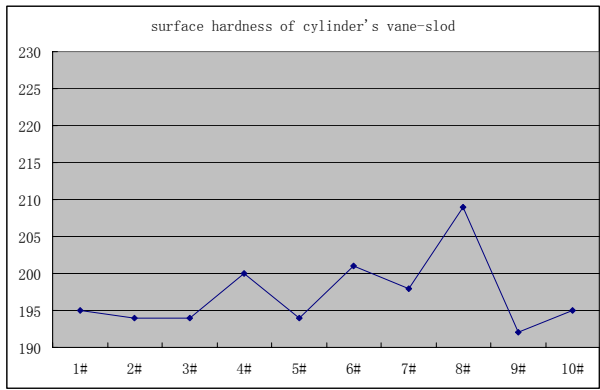
Fig.6 Surface hardness of the cylinder’s vane-slot

From the hardness distribution Graph, The surface hardness of the vane-slot is closed to the lower limit (Requirement value 190 ~ 230).

Currently used, Cylinder hardness of HB 190 ~ 230, actually the hardness of the vane slot is about HB 185. We can improve the cylinder hardness from HB200 to HB240. This can reduce the probability of occurrence of adhesive wear; the drawback is that, with the increase in the cylinder hardness machining process becomes difficult

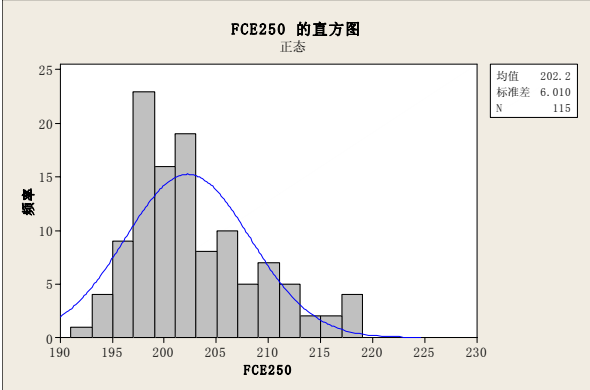
Fig.7 Bulk cylinder hardness distribution

The hardness survey data, Cylinder hardness distribution of FCE250 material, the middle value is close to the lower limit. According to the data, during mass production process, there must be some cylinders having hardness value less than the lower limit.

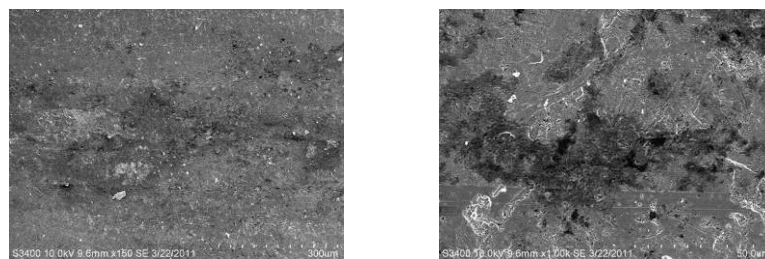
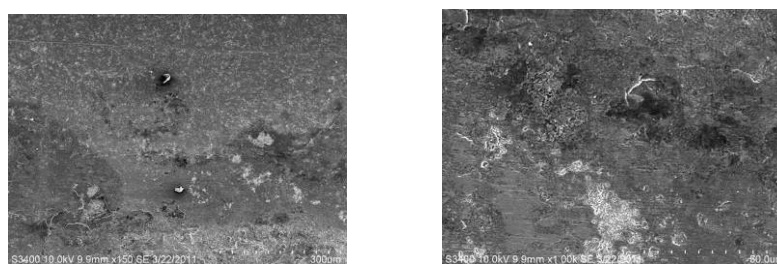
Fig.8 electron microscopy analysis 1

- 1) The friction at the high pressure side is more evident than at the low pressure side. And the friction on the both sides is relatively even, no apparent scratch caused by the foreign particles.

- 2) The black material content shown in the figure has a relatively high ratio of carbide and some other alloy elements but has no nitrogen elements
- 3) The grey and the white area contains nitrogen element and should be nitriding vane surface immersed in the sulphur

- 4) From the linear component analysis, black area has the high ratio of carbon, high ratio of alloy elements, less content of iron and nitrogen
- 5) From the conclusion above temporarily whether the friction caused by the expansion or the material transfer of cast iron cylinder happened at the vane surface. Because no matter the martensite or the remaining austenite leads to the expansion .Vane surface overheated and decarbonizes or the material transfer both will cause the high ratio of carbon and less ratio of iron at the surface

High pressure side friction marks morphology

Low pressure surface friction marks morphology

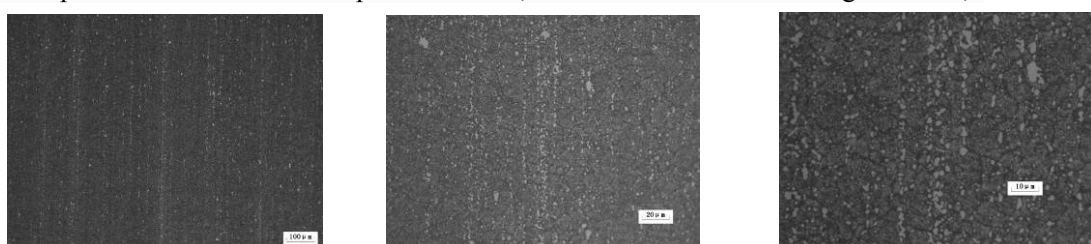
Fig.9 electron microscopy analysis 2

Vane heat treatment process consists of mainly quenching and tempering many times. Metallographic analysis found that carbide grain boundary along the separation, At high magnification, we can observe the needle shaped and hidden needle shaped martensite, but cannot see the remaining austenite,

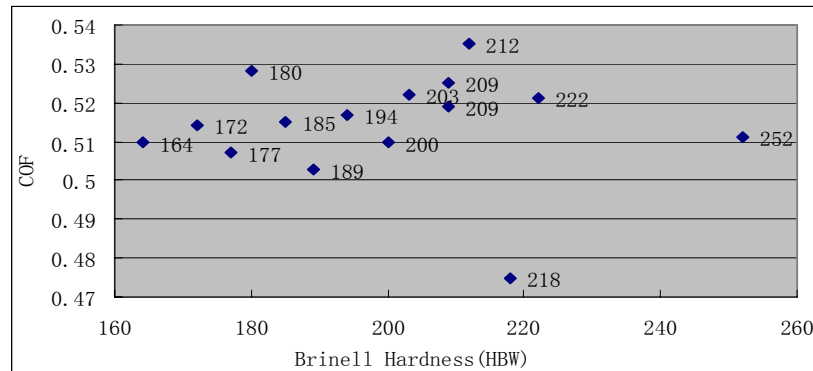
A) With the increase of Hardness, friction coefficient also increases

Fig.10 Relation between coefficient of friction and Hardness

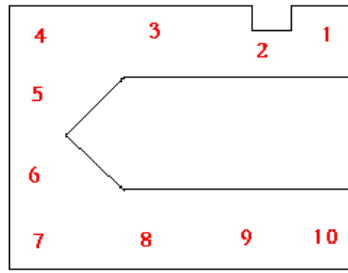
Fig.14 Points selected to measure the deformation

From the statistical data , After assembly of the pump and welding, the part of the vane-slot near upper bearing has larger deformation .Due to which the clearance between the vane and the vane slot decreases
